We are sending you attached the translation into English of the ICOMOS Hellenic press release ( April 6th) on:  
***Drastic building interventions in the Acropolis site, the Athenian Agora and Kerameikos. cause irrevocable damage to the authenticity of the monuments***

## **DRASTIC BUILDING INTERVENTIONS IN THE ACROPOLIS SITE, THE ATHENIAN AGORA ETC. CAUSE IRREVOCABLE DAMAGES TO THE AUTHENTICITY OF THE MONUMENTS**

### **Dramatic appeal of ICOMOS Hellenic to the G Ministry of Culture to stop the arbitrary interventions and submit immediately necessary files to UNESCO**

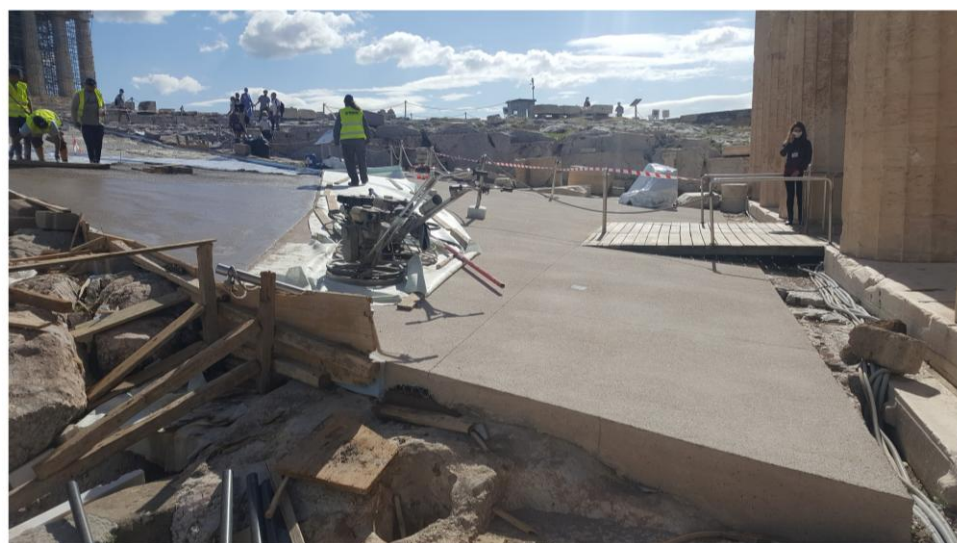
FIG. 1b. The area east of the Propylaia, in the process of being paved with reinforced concrete, covering over the face of the living rock. The wet cement on the picture's left end is covering the plastic sheet and metal mesh, seen in FIG. 1a.

View from the NW corner of the platform. Above left, the west end of the Parthenon. Photo: Tasos Tanoulas, October 29, 2020.

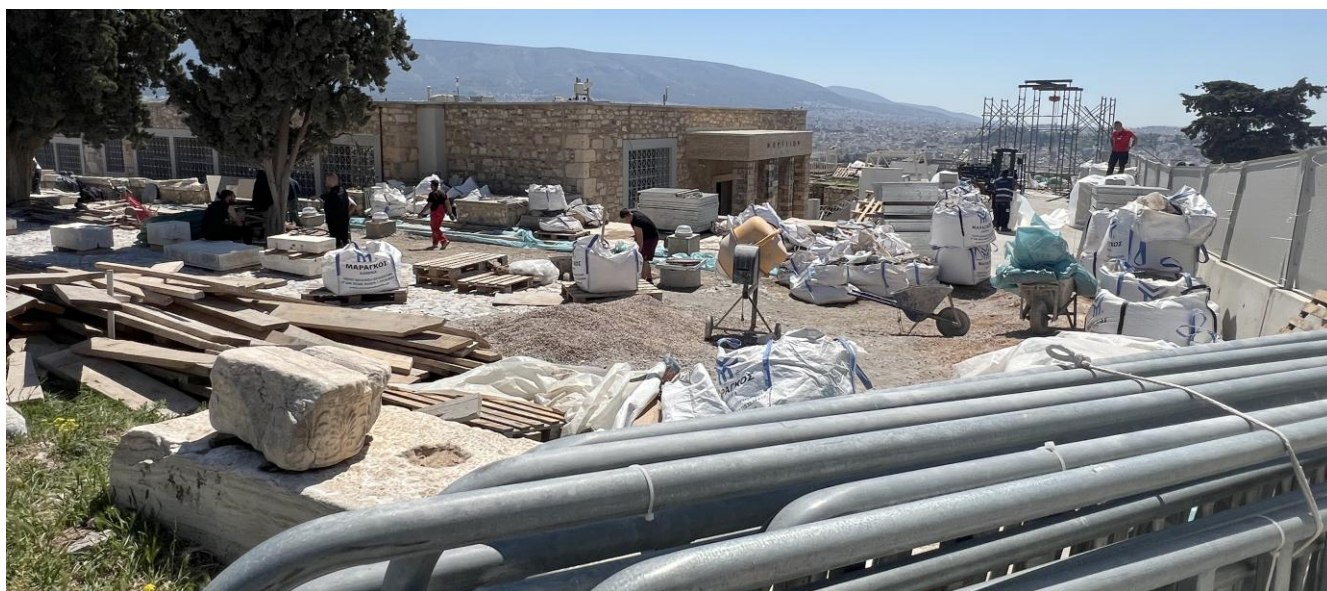
FIG. 3. View in the southeast area of the Acropolis plateau, showing part of the work-site to the north and west of the old museum of the Acropolis. The mess is obviously due to many small multi-purposed projects going on in a slow pace for almost two years. At the background: mount Hymettus and the old museum.

The NE area of the plateau was for a long time inaccessible to visitors because of ancient remains; in the last two years it has been extended to the north and west, with the excuse of the implementation of structural works for the transformation of the old Acropolis museum for serving new functions, the refurbishment and extension of the visitors' toilets on the plateau, and for the consolidation of the Acropolis walls and other antiquities. (FIG. 3) It seems very probable that the rather robust implementations at the southeast corner of the Acropolis, just inside the ancient walls, are projected towards accommodating a second elevator, which the Minister of Culture has already announced. One wonders why, instead of fixing the elevator built in 2020, a new one is planned to be established at an even more conspicuous place.

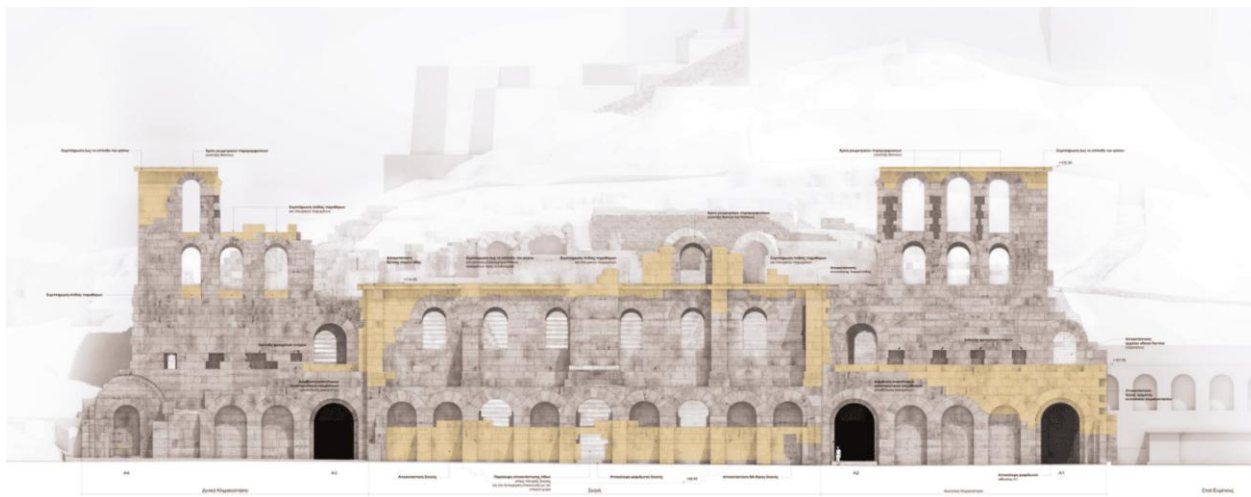
FIG. 5a. The south front of the Odeion of Herod Atticus, after the projected reconstruction. Reconstructed parts indicated in yellow. Source: LIFO, 23.2.2026

The Odeion of Herod Atticus in the immediate proximity of the south wall of the Acropolis and the west access, is closely connected with the iconic image of the Acropolis rock and plateau from the south and south west. The Odeion of Herod Atticus will be closed to the public for over three years, for massive reconstruction, rehabilitation and updating of the mechanical equipment for the needs of the annual Athens Festival, which is held in the monument in summer. (FIG. 4-5) Accessible documents show as most probable that the study and the realization of the work will be assigned to contractors with non-transparent procedures, while no reference is made to the need of complying with the national legal framework and other guidelines of the World Heritage Convention.

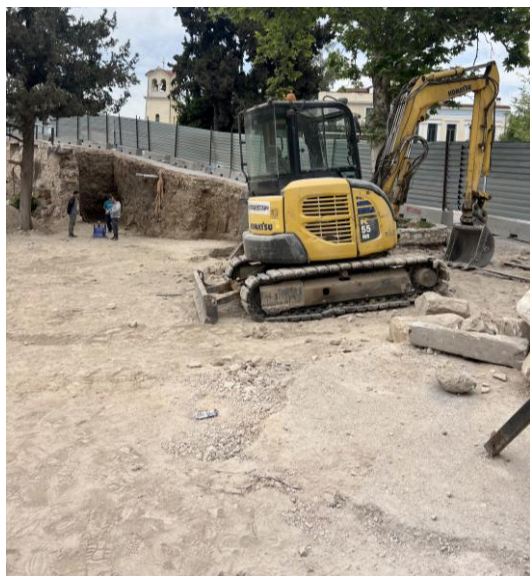
FIG. 6

FIG. 6. Digging inside the northern entrance of the Athenian Agora, view from the south. Caterpillar machinery is used. Source: Tasos Tanoulas, May 2025.

New buildings have been erected since last spring, to serve as ticket offices for the entrance at the site's north. Instead of proper systematic excavation, heavy caterpillar machinery was used for digging; the vertical surface of dirt revealed, was covered by a tall retaining wall of reinforced concrete, facing southwest. (FIG. 6-7) New pavement of concrete is under construction across the Agora, over the Panathenaic Way from northwest to southeast. At the southeast corner of the Agora, the foundations of a Roman temple, known as the Southeast Temple, are being covered with reinforced concrete, poured at the site. The door sill and the lower parts of the walls of the cella, the krepis (that is, the formal steps of Greco-Roman architecture) of the porch facing north have already been "reconstructed" in reinforced concrete. Most probably, the "reconstructed" krepis is destined to bear a number of Ionic columns which are attributed (in second-hand use) to the north façade of the temple; these columns originate from the classical temple of Athena Sounias (the original foundations are identified at cape Sounion) and are now lying nearby. However, the erection of the columns cannot justify the ceiling of the ancient foundation under massive structures of reinforced concrete. (FIG. 8) Nevertheless, very close to the northeast temple, more steps are reconstructed with reinforced concrete, on top of surviving original roman steps lining the Panathenaic way on the west side, to allow access at a platform before the east end of the Middle Stoa. (FIG. 9) It seems that there are no proper studies for the reconstructions, as all the works appear in the frame of a rainwater drainage implementation project.

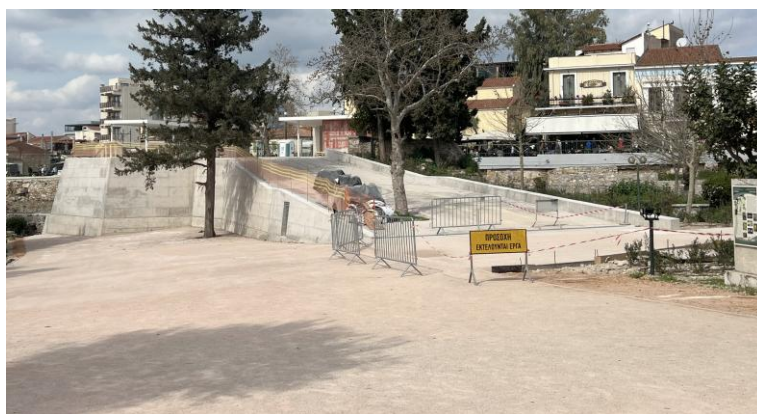
FIG. 7

FIG. 7. Inside the northern entrance of the Athenian Agora, from the almost same point of view as in fig. 6. The work is completed. Source: Tasos Tanoulas, March 2026.

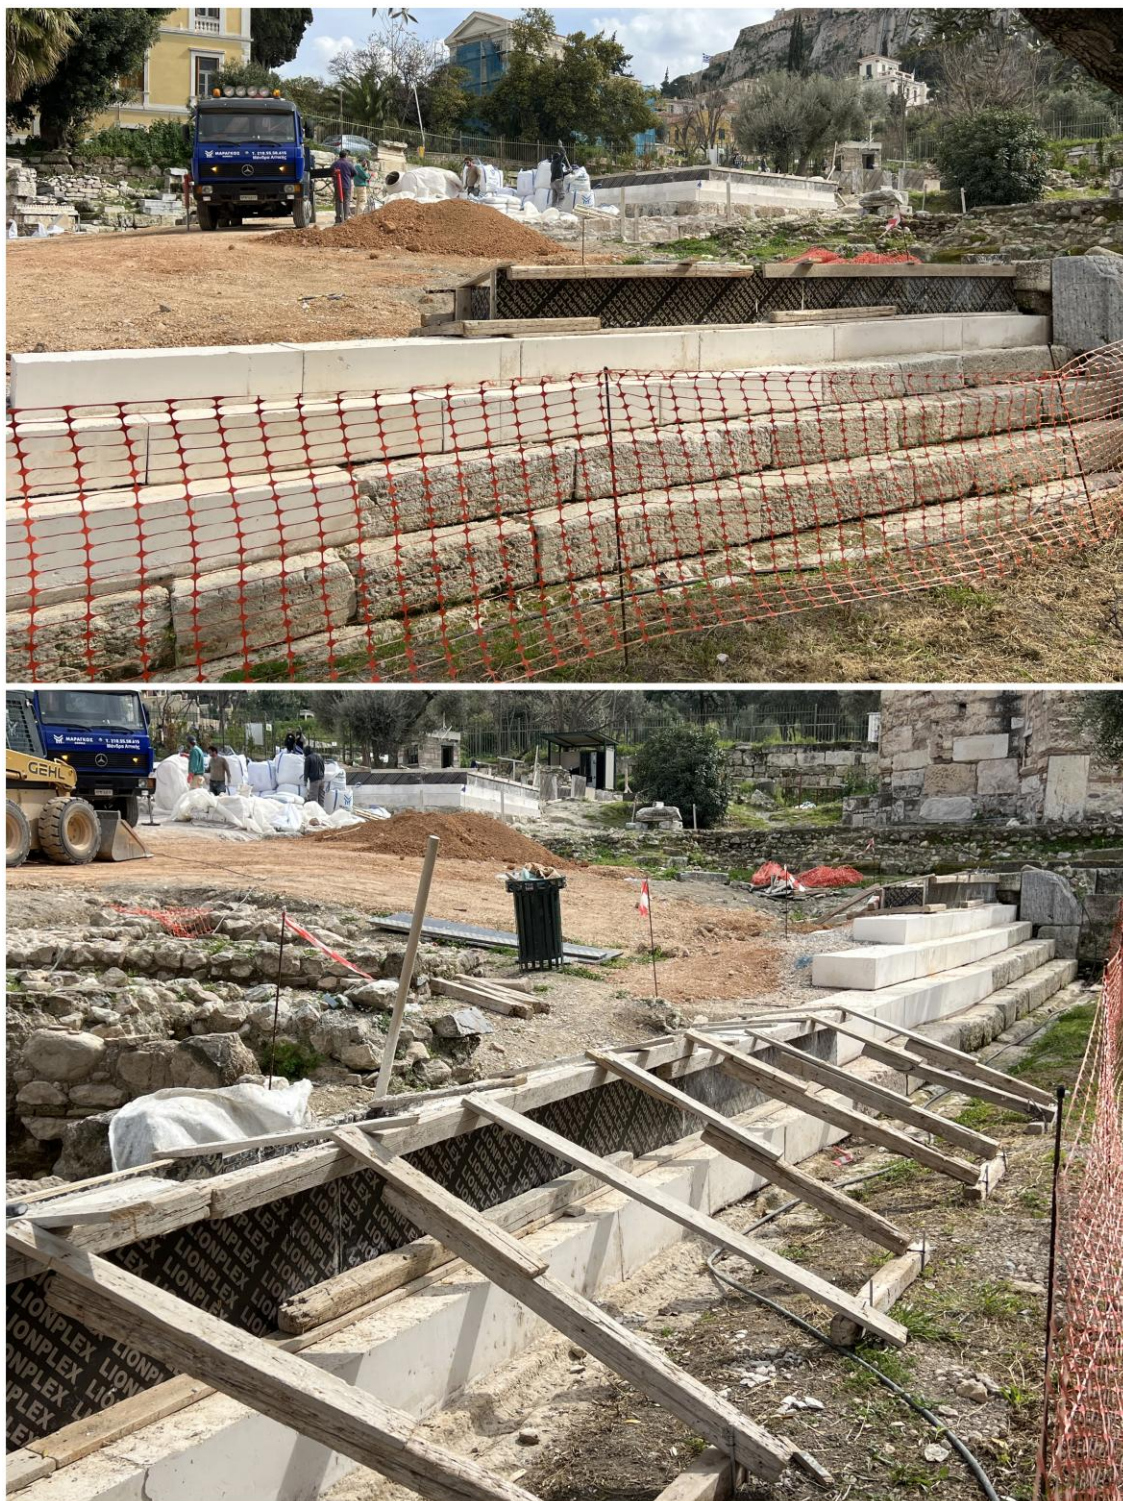
FIG. 9. On top of original Roman steps, before the east end of the Middle Stoa in the Athenian Agora, new steps are being “reconstructed” in reinforced concrete.

a. Detail and b. general view. At the upper level of both Figures, the SE Temple seen from NW. Source: Tasos Tanoulas, 20.2.26

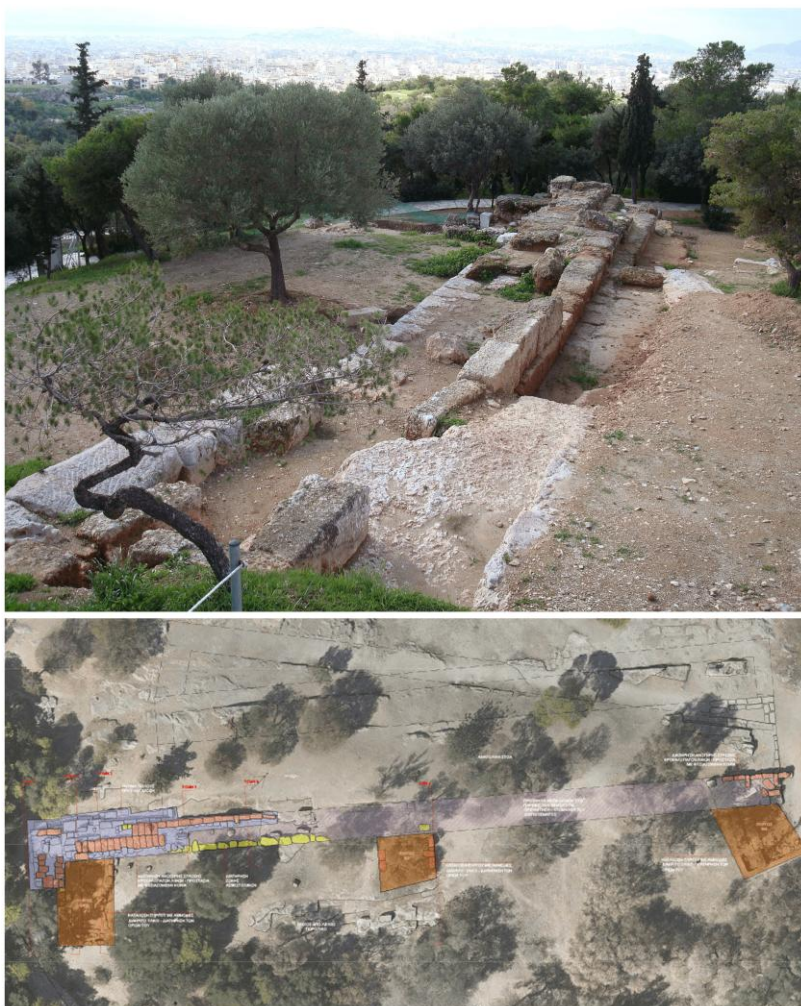
FIG. 10.

- a. A view of surviving parts of the "Diateichisma". Source: Ministry of Culture.
- b. An aerial view of surviving parts of the "Diateichisma", indicating projected interventions for "enhancement". Source: Ministry of Culture.

Works have been announced for the enhancement of the 'diateichisma', that is, the fifth century B.C. ancient wall between the hill of the Nymphs and the hill of Muses (Philopappos Hill). (FIG. 10)
